**DEPARTMENT OF TRANSPORTATION**

Contract #: 04-0120F4Cty: SF/ALA Rte: 80 PM: 13.2/13.9File #: 69.28**WELDING INSPECTION REPORT****Resident Engineer:**Pursell, Gary**Address:** 333 Burma Road**City:** Oakland, CA 94607**Report No:** WIR-015575**Date Inspected:** 07-Jun-2010**Project Name:** SAS Superstructure**OSM Arrival Time:** 700**Prime Contractor:** American Bridge/Fluor Enterprises, a JV**OSM Departure Time:** 1900**Contractor:** Zhenhua Port Machinery Company, Ltd (ZPMC), Changxing Island **Location:** Shanghai, China**CWI Name:** Mr. Li Jia**CWI Present:** Yes No**Inspected CWI report:** Yes No N/A**Rod Oven in Use:** Yes No N/A**Electrode to specification:** Yes No N/A**Weld Procedures Followed:** Yes No N/A**Qualified Welders:** Yes No N/A**Verified Joint Fit-up:** Yes No N/A**Approved Drawings:** Yes No N/A**Approved WPS:** Yes No N/A**Delayed / Cancelled:** Yes No N/A**Bridge No:** 34-0006**Component:** Orthotropic Box Girder( OBG)**Summary of Items Observed:**

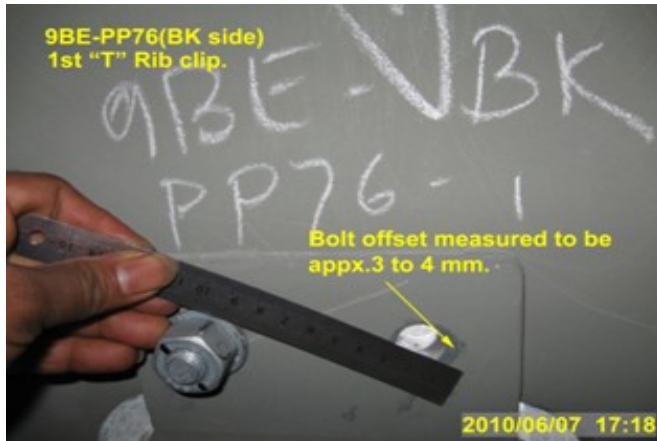
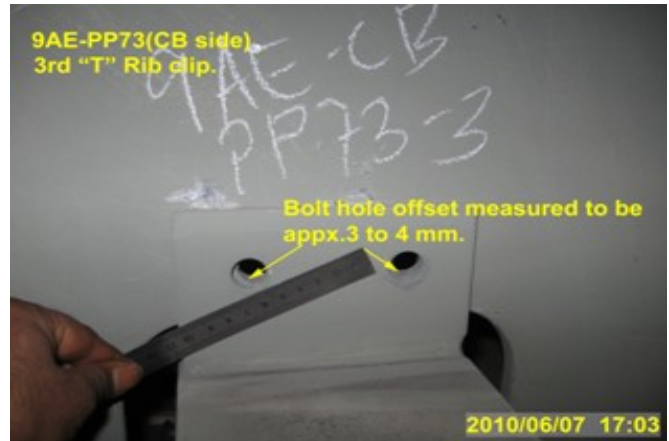
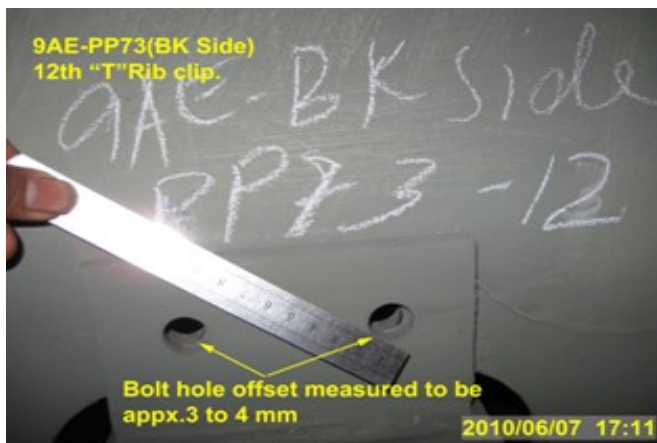
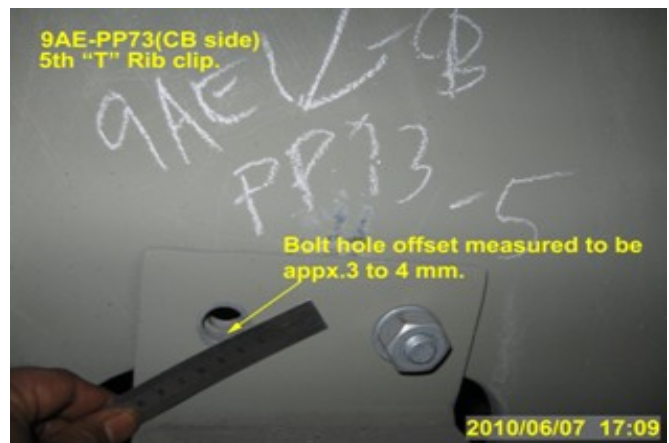
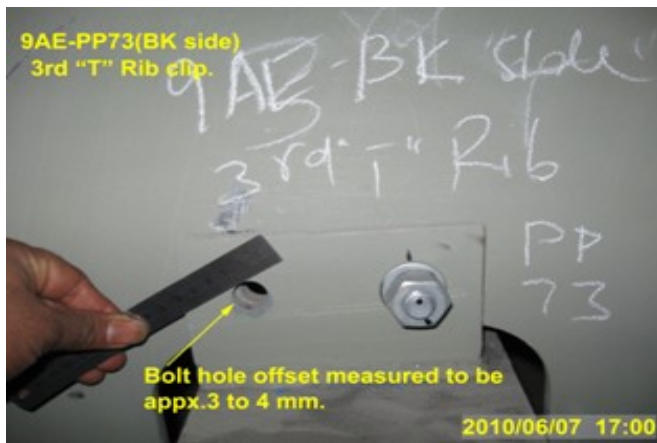
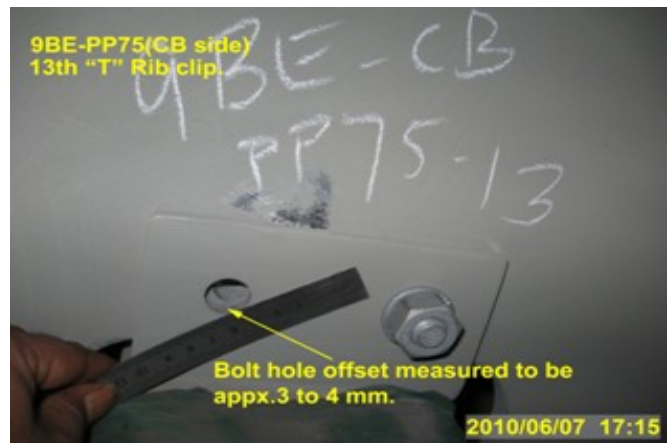
This QA observed that six bolts have not been installed due to bolt hole misalignment. ZPMC Quality Control (QC) identified as Mr. Zhang Hai Jun informed this QA that ZPMC will correct the misaligned holes and re-notify Caltrans (CT) for inspection at a later date. This issue has been reported to CT lead inspector and recorded on CT NWIT tracking sheet 00371. See attached photos for details.

1. PP#73-Side plate (Bike Path side) "T" Rib#3 and 13.
2. PP#73-Side plate (Crossbeam side) "T" Rib#3 and 5.
3. PP#75-Side plate (Crossbeam side) "T" Rib#13.
4. PP#76-Side plate (Bike Path side) "T" Rib#1.
